**DEPARTMENT OF TRANSPORTATION**

Contract #: 04-0120F4Cty: SF/ALA Rte: 80 PM: 13.2/13.9File #: 69.28**WELDING INSPECTION REPORT****Resident Engineer:** Pursell, Gary**Address:** 333 Burma Road**City:** Oakland, CA 94607**Report No:** WIR-001909**Date Inspected:** 07-Apr-2008**Project Name:** SAS Superstructure**OSM Arrival Time:** 1400**Prime Contractor:** American Bridge/Fluor Enterprises, a JV**OSM Departure Time:** 100**Contractor:** Zhenhua Port Machinery Company, Ltd (ZPMC), Changxing Island **Location:** Shanghai, China**CWI Name:** Chen Xie**CWI Present:** Yes No**Inspected CWI report:** Yes No N/A**Rod Oven in Use:** Yes No N/A**Electrode to specification:** Yes No N/A**Weld Procedures Followed:** Yes No N/A**Qualified Welders:** Yes No N/A**Verified Joint Fit-up:** Yes No N/A**Approved Drawings:** Yes No N/A**Approved WPS:** Yes No N/A**Delayed / Cancelled:** Yes No N/A**Bridge No:** 34-0006**Component:** OBG deck panels**Summary of Items Observed:**

OBG bay 1 (Gantry 1)

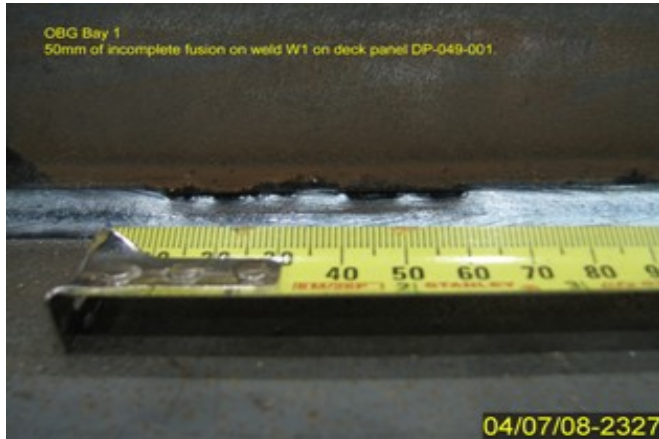
QA visually inspected completed welds on deck panel DP-301-001. All welds that were inspected appeared to exhibit some degree of lack of fusion, overlap, oversize and/or under fill. All of the (PJP) welds joining U-Rib to deck plate on this panel do not comply with the visual acceptance criteria specified in AWS D1.5 2002 and the contract documents and are rejected. QA completed a Caltrans QA visual weld inspection report for the OBG deck panel mentioned above.

NOTE: ZPMC and/or ABF QC have not completed their visual inspection of this deck panel at this time.
